Manhole Inspection Summary

Manhole # S31C__004MH

Insp Date: **8/7/08 3:41 PM**

Location Address: **side 320 w mulberry st**

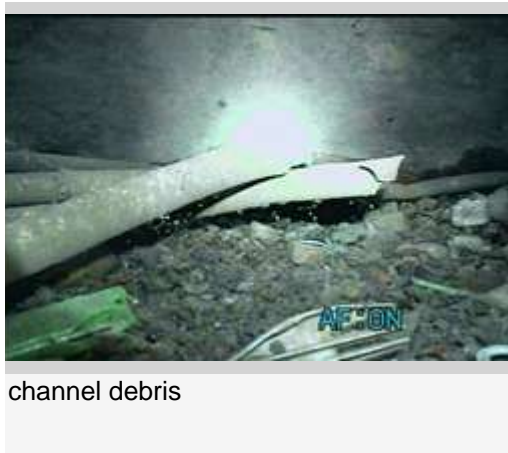
Defect 3

Condition: ☐ Sound ☐ Cracked ☐ Root Intrusion ☐ Deteriorated ☐ Leaks ☒ **Debris**

channel debris

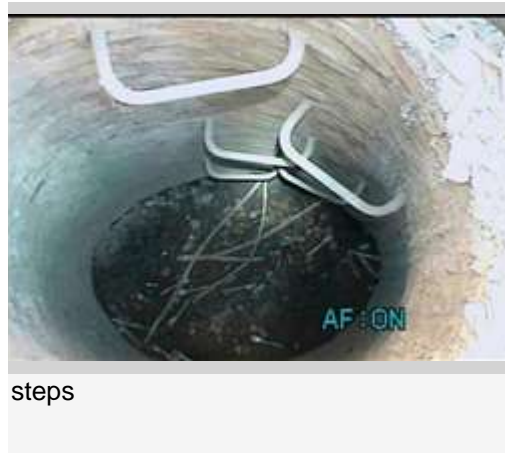
Defect 2

Steps Count: **5** Missing: **0** ☒ **Corroded**

steps

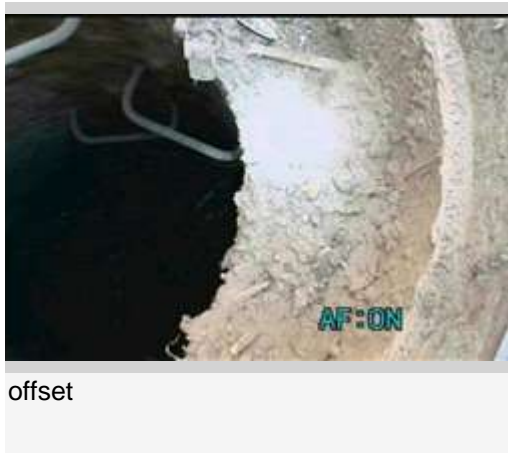
Defect 1

Frame Offset: **4.5** (in.) Condition: ☒ Sound ☐ Cracked ☐ Leaks

offset

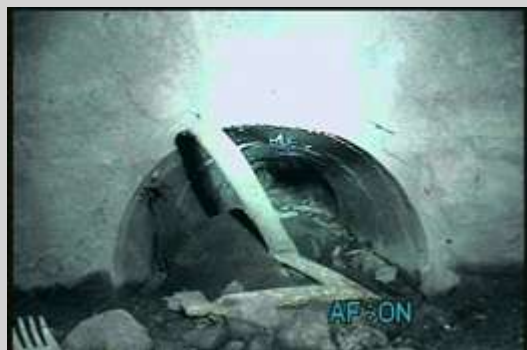
12 O'Clock Outflow

8 in. Circular Gravity Sewer
Pipe Out @ 12 O'Clock

Deposits: ☐ None ☐ Mud ☐ Sludge ☒ **Debris** ☐ Grease

Silt Depth: 3 (in.) Deposits Extent: **Light**
